TECHNICAL MEMORANDUM

SUBJECT: **PRELIMINARY ASSESSMENT OF SLOPE STABILITY, IRON GATE AND
COPCO DAMS AND RESERVOIRS, UNDER RAPID DRAWDOWN**

PROJECT NO.: 06-201

DATE: November 27, 2006

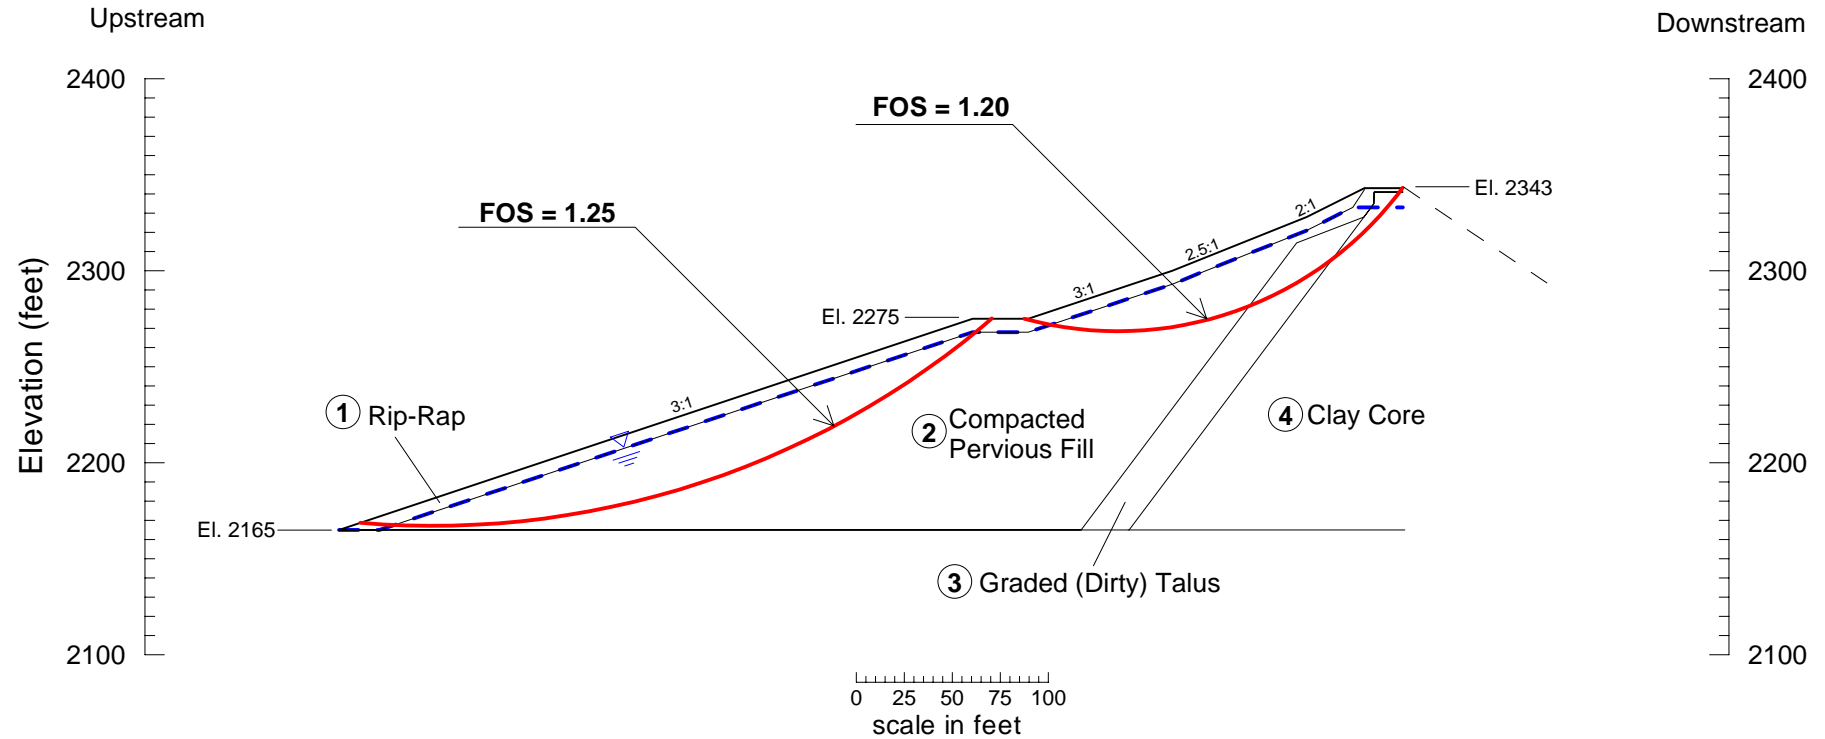
**RAPID DRAWDOWN
STABILITY ANALYSIS -
SOIL PROPERTIES PER STATE
OF CALIFORNIA ANALYSIS (1960)**

The stability of the upstream face of the dam was first evaluated utilizing the soil properties defined in the original stability analysis conducted by the State of California (September 16, 1960). While the materials in zone 1 and zone 1A are expected to differ somewhat, we used the California zone 1 soil properties for both zones in this analysis. This was based on the inference that the zone 1A materials, while dirtier than the zone 1 material, still met specification. Differing slightly from the 1960 analyses which did not include rip rap in the stability evaluation, our model included rip rap with an assumed friction angle of 42 degrees and a unit weight of 125 pcf.

As seen in Figures 1 and 2, the lowest factor of safety was found to correspond to a circular failure surface near the top of the slope, where the slope face is steepest. Factors of safety of 1.20 and 1.38 were calculated for the upper slope utilizing the original soil properties and revised soil properties, respectively. A circular failure surface through the toe of the slope was also analyzed. As shown on Figures 1 and 2, the lower circular surface had computed factors of safety of 1.25 and 1.45 utilizing the original soil properties and revised soil properties, respectively.

The computed factors of safety from our stability analyses are within or exceed factors of safety of 1.1 to 1.3 established by the US Army Corps of Engineers (EM-1110-2-1902) as being acceptable for the rapid drawdown conditions of the upstream shell of dams. Consequently, we believe that the existing upstream dam face will be globally stable during reservoir drawdown.

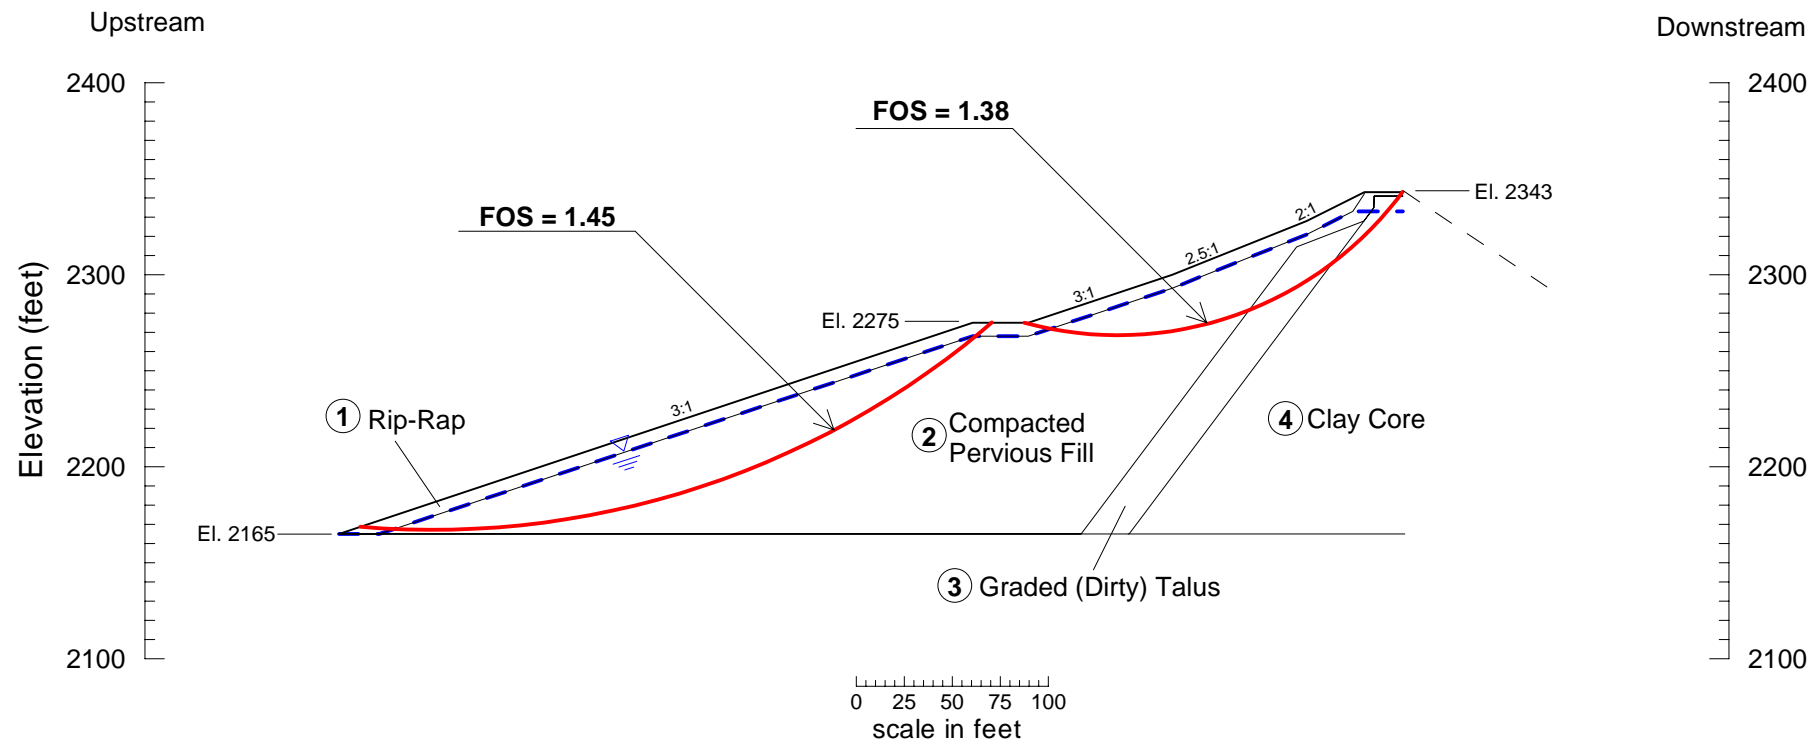
**RAPID DRAWDOWN
STABILITY ANALYSIS -
SOIL PROPERTIES USED
IN CURRENT ANALYSIS**

A second stability analysis was then conducted utilizing revised (stronger) soil properties for the upstream shell (i.e. Zones 1 and 1A) as based on our understanding of the actual materials used to construct the shell. Figure 2 presents the soils parameters used for this analysis.
